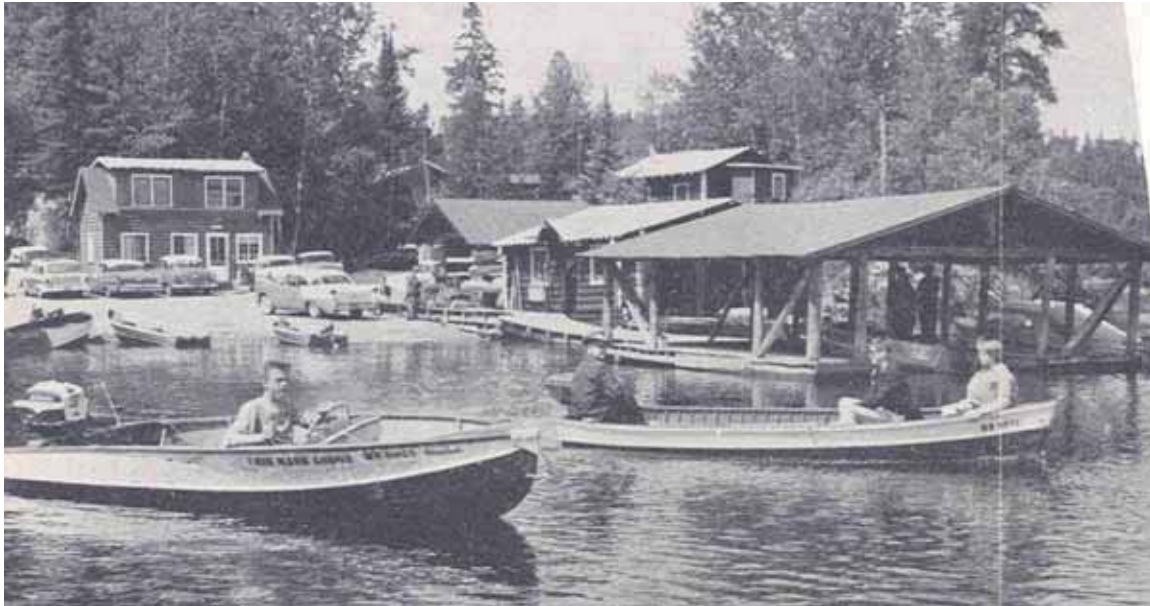
**Figure 4- 14: HV#4, Historic View of office, boathouse and area around docks from the water ca.1960. (source: C-W 240a, excerpt from Chik-Wauk brochure, page 2)**

Historically, spending time at Chik-Wauk Resort included getting out on the water in boats. HV#4 illustrates a typical historical scene at the resort, viewed from a boat in North Bay, where boaters departed and returned from fishing trips and other excursions. From the water, the lodge was in the background and multiple other buildings, including the office, boathouse, canoe outfitters building, and #4 Cabin were visible. Docks, boat landings, and automobiles were also important elements in the scene. A similar existing view presents a less active scene due to the loss of boats, buildings, and docks in this area.

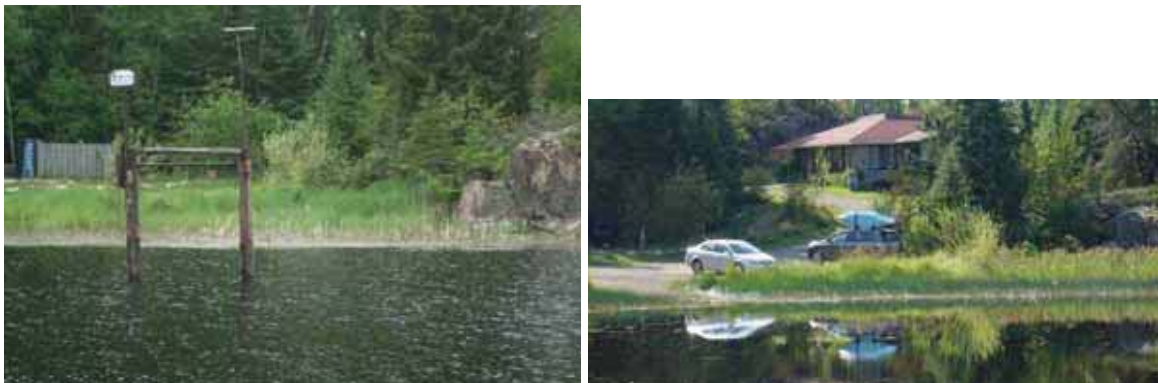
**Figure 4- 15: EV#4 Existing View of parking area from the water and lodge from across the bay, August 2012 and July 2013 (source: QEA and Bruce Kerfoot)**

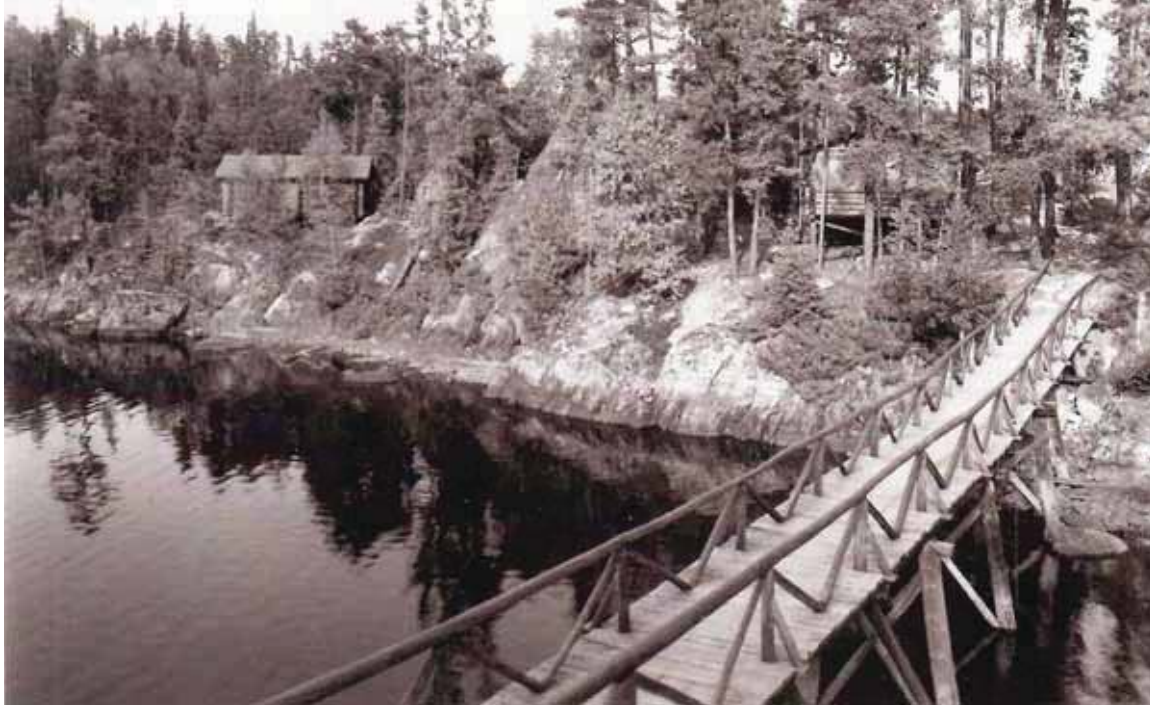
**Figure 4- 16: HV#5, Historic View of Carey Cabin (#1 Cabin) at left, Judge's Cabin (#2 Cabin) at right, and pedestrian bridge, facing east, ca. 1940s (source: Nancy Nunstedt Bergen)**

Access to the “Cabin Across the Bridge” (#3 Cabin) was provided by a wood pedestrian bridge from the north development area. The view from this cabin to the east included the bridge, rocky shoreline, and cabins perched on the rock outcrops. Although the bridge and cabins are no longer extant, the rocky shore line has remained greatly intact and recognizable.

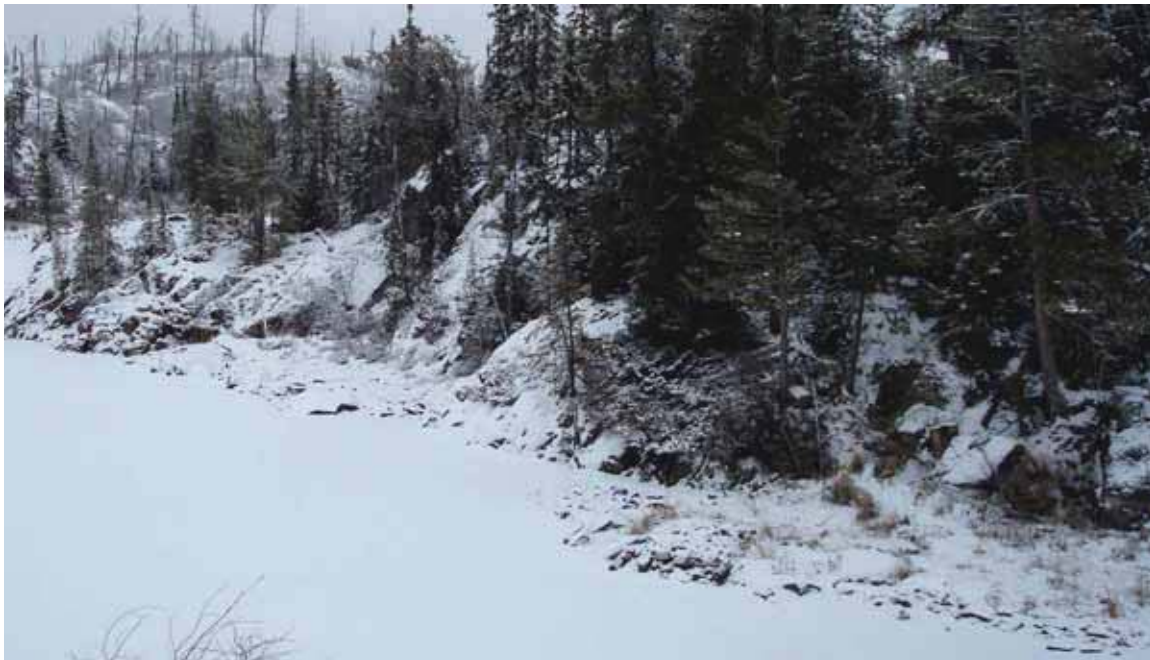
**Figure 4- 17: EV#5, Existing View from similar vantage as HV#5, in the winter, December 2012 (source: QEA)**

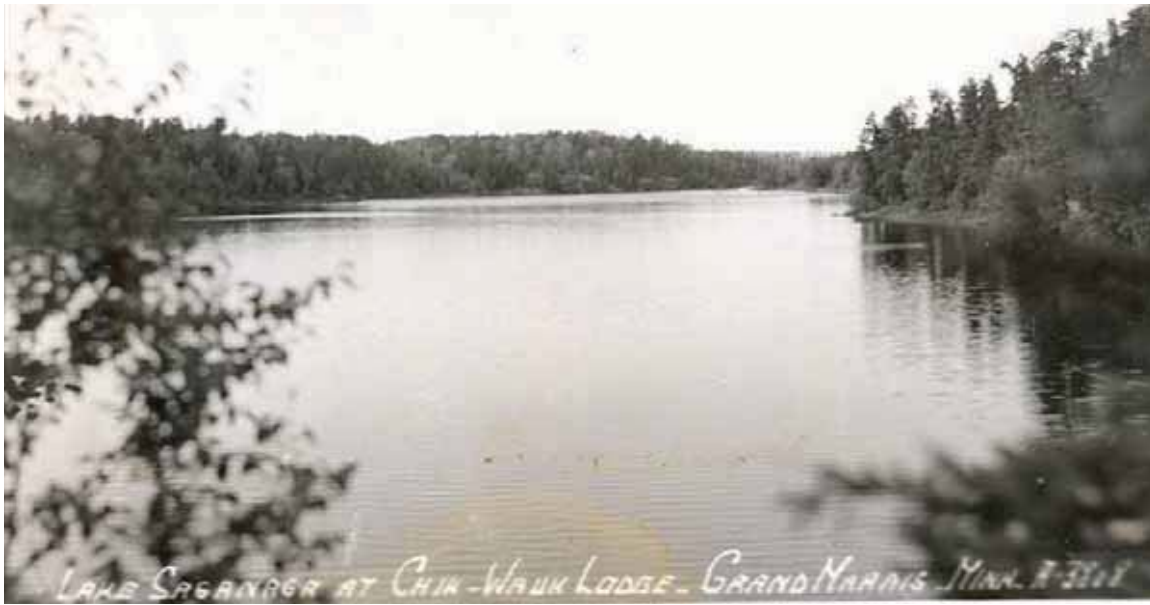
Figure 4- 18: HV#6, Historic View of Lake Saganaga from Chik-Wauk Resort (source: C-W 20)

Views of Saganaga Lake to the north from Chik-Wauk were expansive and beautiful, presenting a seemingly unexplored wilderness. This remains true today, as the view is greatly unchanged. The appearance of two vacation homes in the distance is a reminder of the fragility of this view. It remains intact because the landscape has remained the same and also because development of new elements have not imposed upon the view.

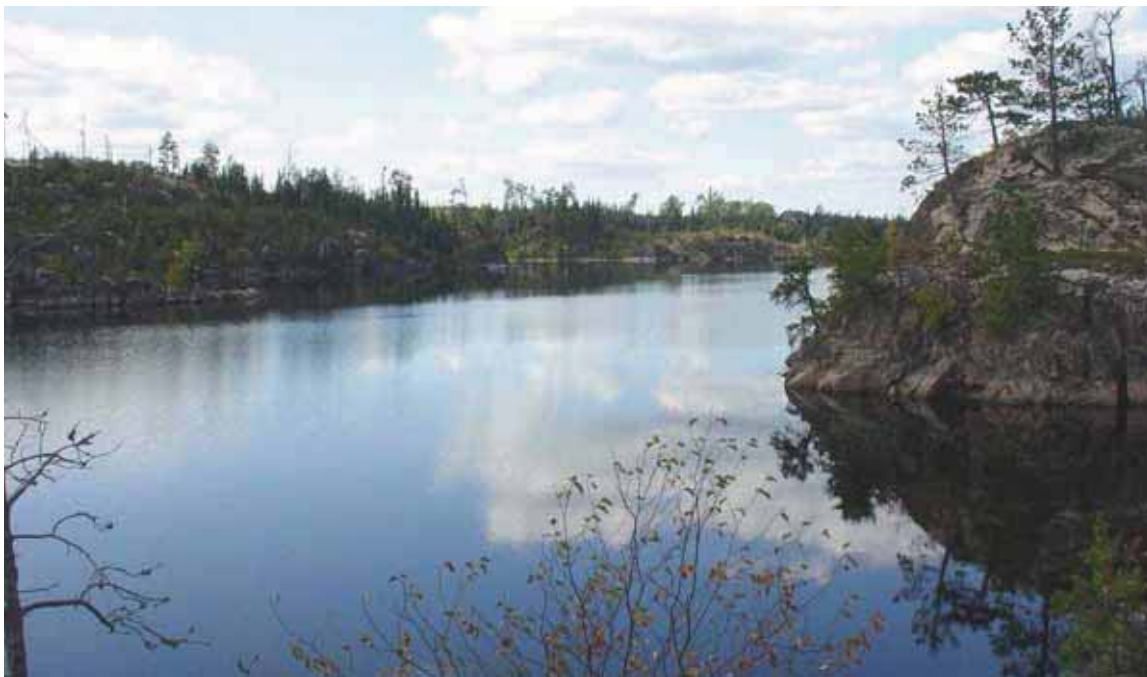
Figure 4- 19: EV#6, Existing View from site of Cabin #1 to the north toward Saganaga Lake, August 2012, compare to HV#6. (source: QEA)

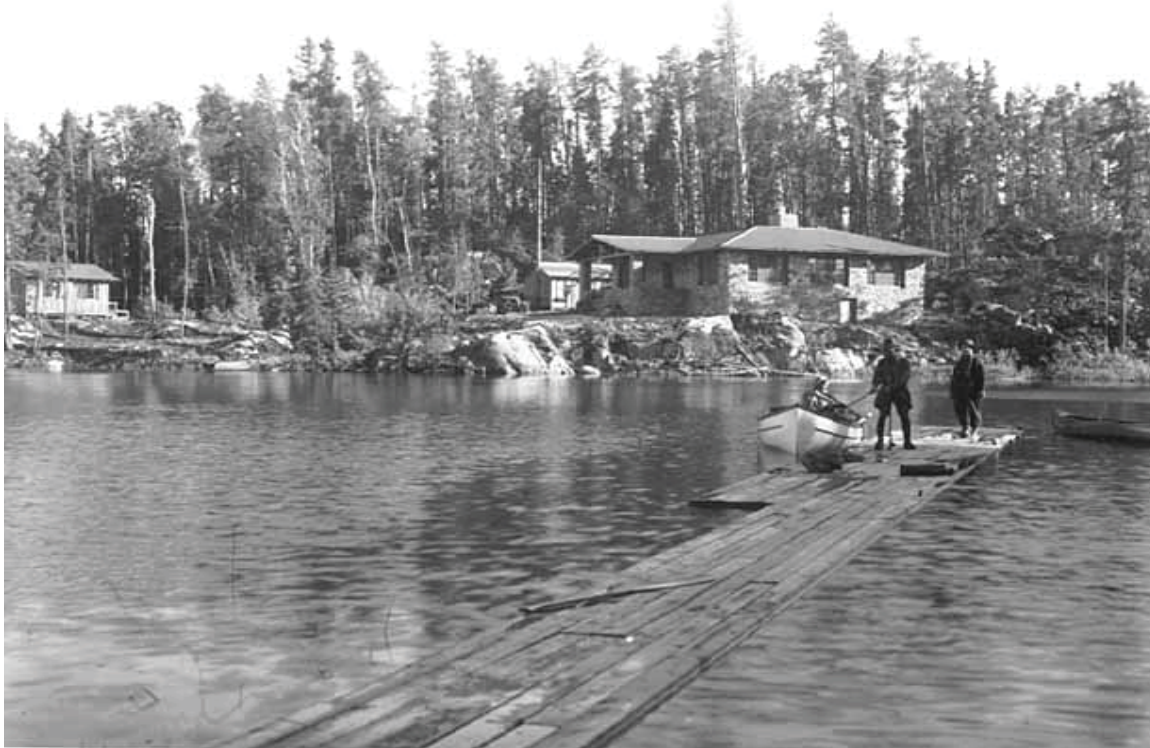
**Figure 4- 20: HV#7, Historic View of Chik-Wauk lodge and surrounding area from across the bay, facing south, ca. 1936 (source: USFS)**

Viewed from across the bay, the grading of the lodge site to create a level building location is apparent. Fill was added on the east side of the building. Today vegetation partially obscures views of the lodge from across the bay, but the scene is otherwise unchanged.

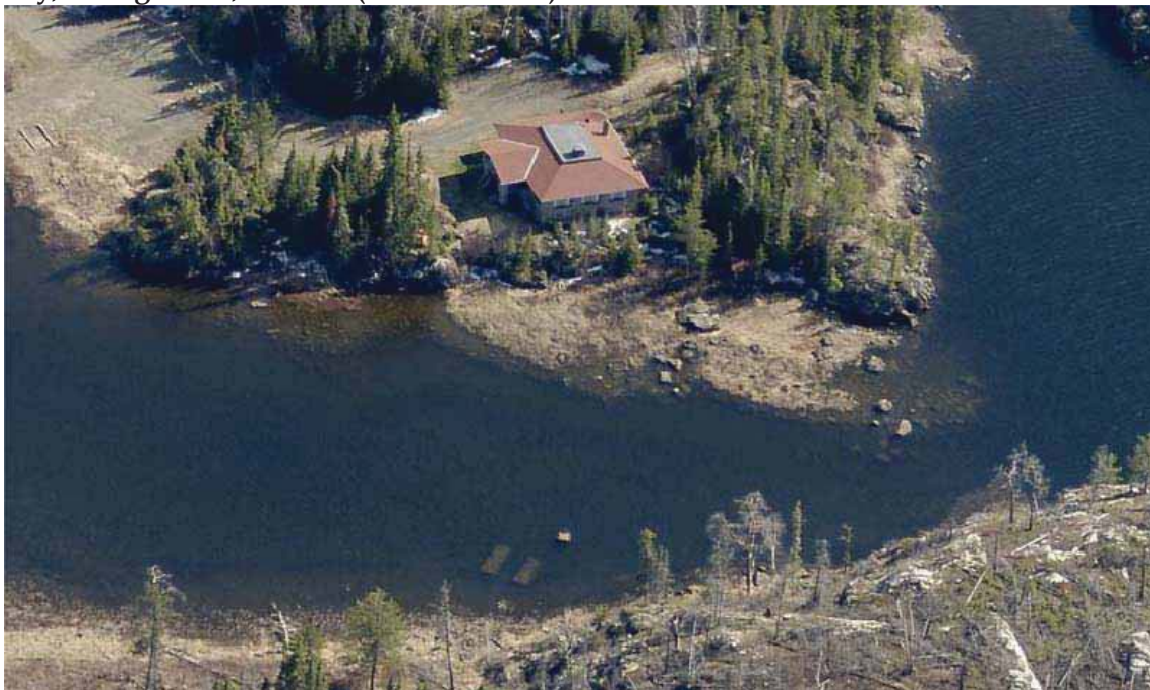
**Figure 4- 21: EV#7, Existing oblique aerial View of Chik-Wauk lodge and surrounding area from across the bay, facing south, 2013 (source: Bing Maps)**

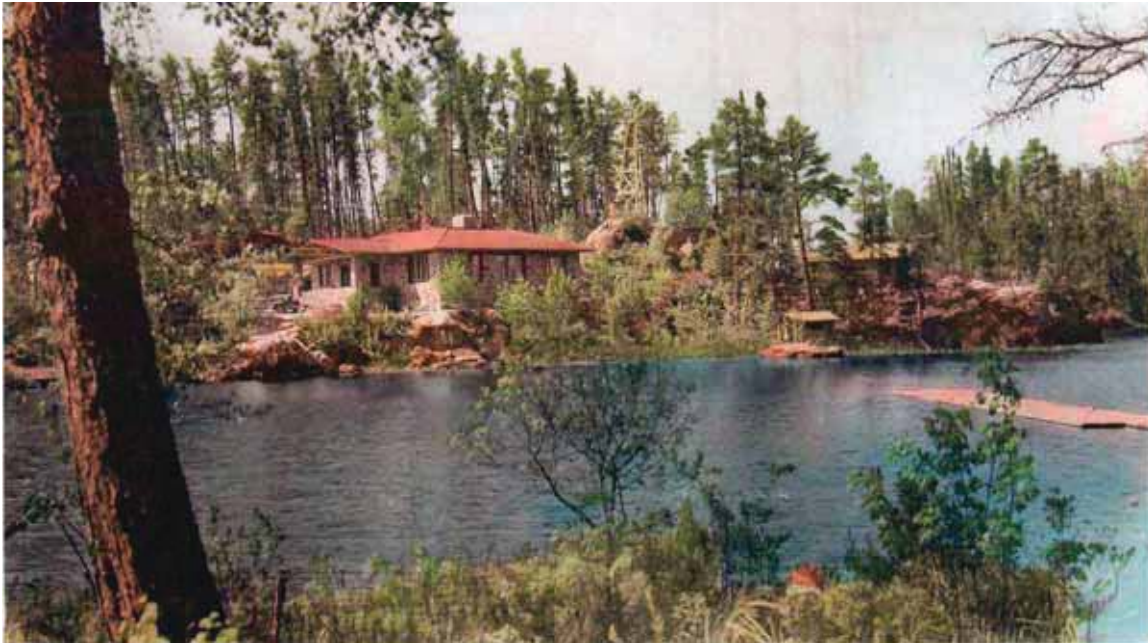
**Figure 4- 22: HV #8, Historic View of Chik-Wauk lodge and surrounding area from across the bay, facing south, ca. 1936 (source: Nancy Nunstedt Bargen -this is the same as C-W 6, with color added)**

The relationship between the lodge, generator building, and Carey Cabin (#1 Cabin) is apparent in HV #8 and EV#8. Although the Carey Cabin is no longer extant, the rocky outcrop upon which it was situated remains. The wind turbine on the high point behind the lodge, and the laundry building to the south of the lodge are apparent in HV#8 as well. Comparison of these two images show the relationship between the lodge and surrounding landscape has changed very little.

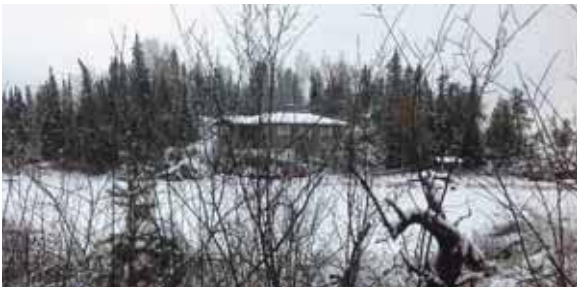
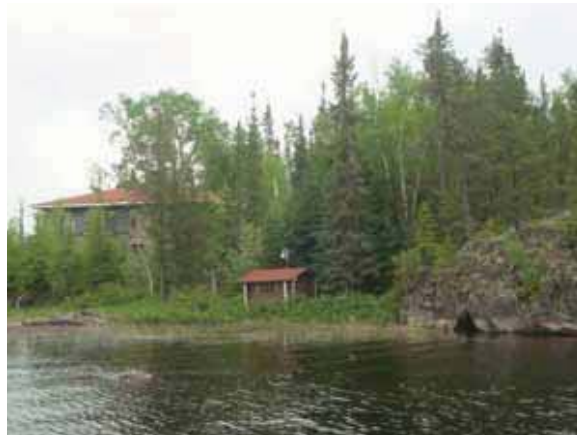
**Figure 4- 23: EV#8, Left: Existing View of Chik-Wauk lodge and surrounding area from across the bay, facing south, December 2012 (source: QEA); Right: Existing View of Chik-Wauk lodge and generator building from the water, July 2013 (source: Bruce Kerfoot)**

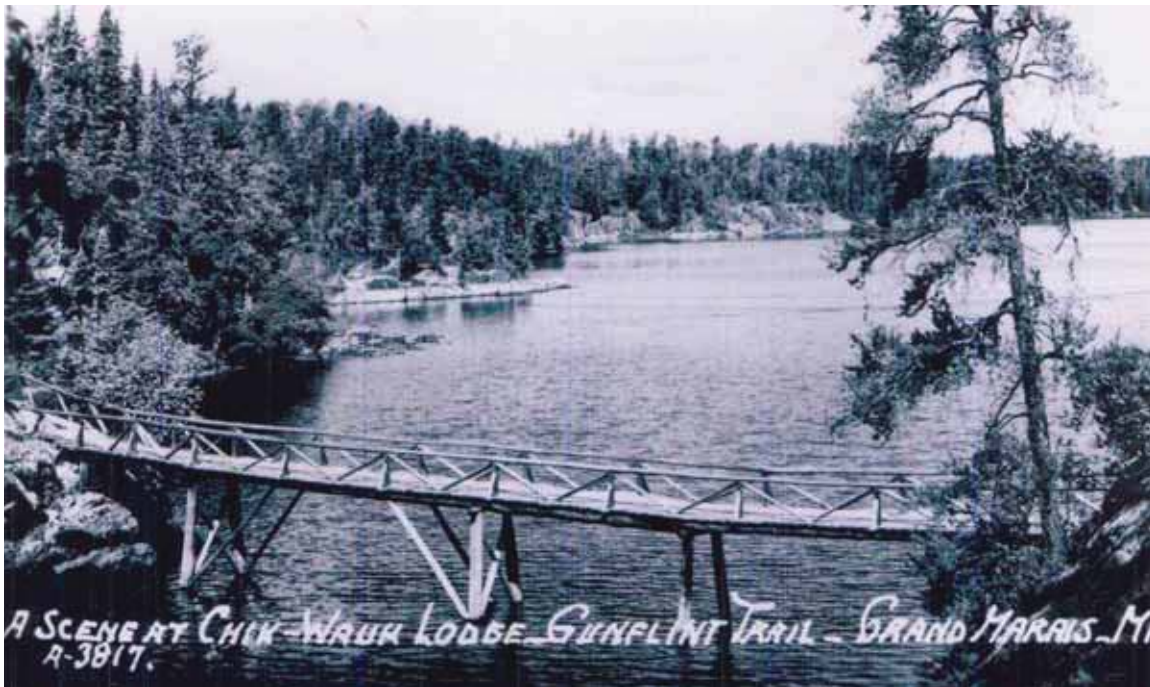
Figure 4- 24: HV#9, Historic View of pedestrian bridge and Saganaga Lake, from site of Crow’s Nest Cabin (#6 Cabin), facing northwest (source: C-W 71)

Views from all of the American Plan Cabins were excellent during the period of resort operation (1931-1980). HV#9 illustrates the historic view from the Crow’s Nest Cabin (#6 Cabin). The pedestrian bridge in the foreground provides an interesting built element in the otherwise naturalistic scene. Today the bridge is absent, but the shores of Saganaga Lake have remained consistent and the view is greatly intact. The lack of visible new development in this view is an important aspect as well.

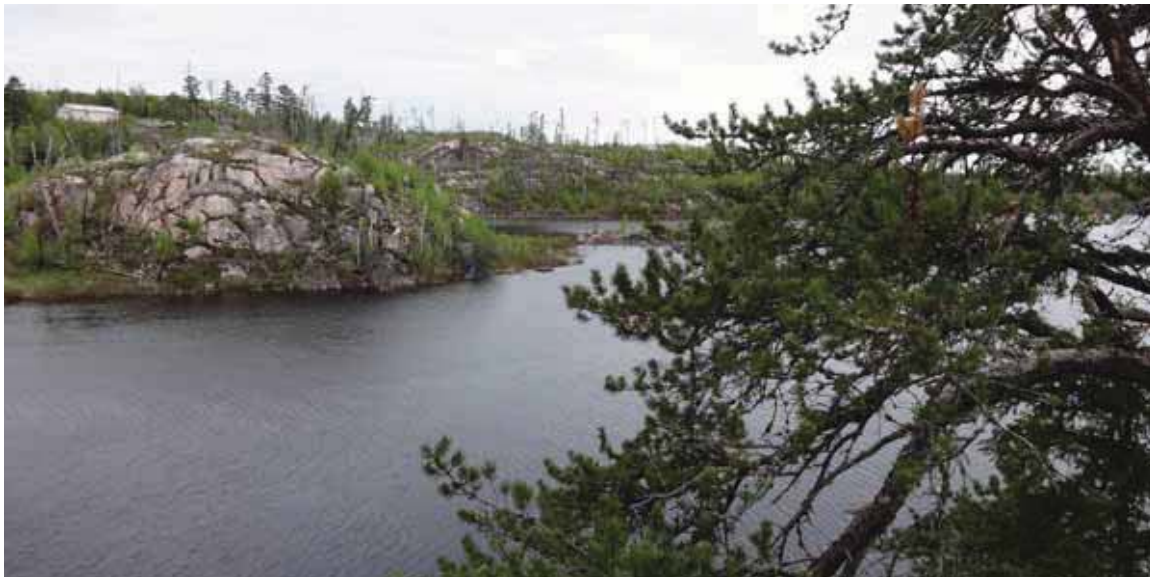
Figure 4- 25: EV#9, Existing View at similar location of HV#9, facing northwest (source: QEA)

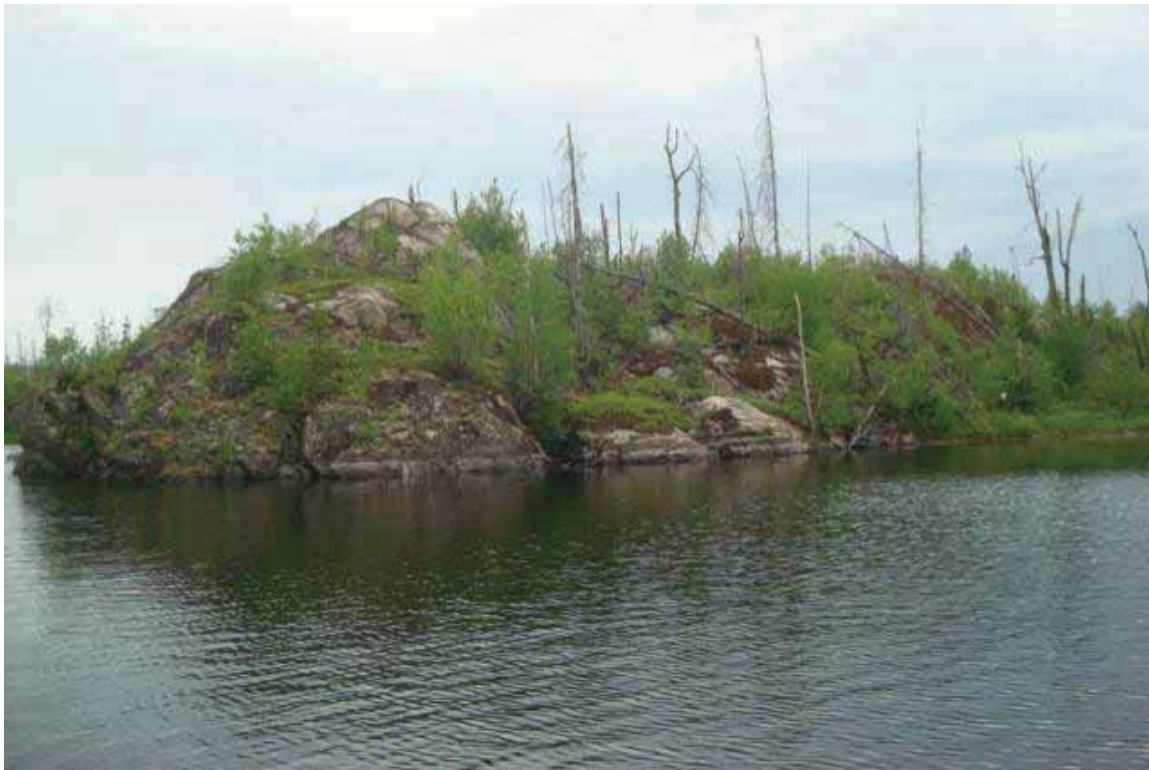
**Figure 4- 26: Rock outcrops at the edge of Saganaga Lake, facing west toward the former site of the Cabin Across the Bridge (#3 Cabin), July 2013. (source: Bruce Kerfoot)**

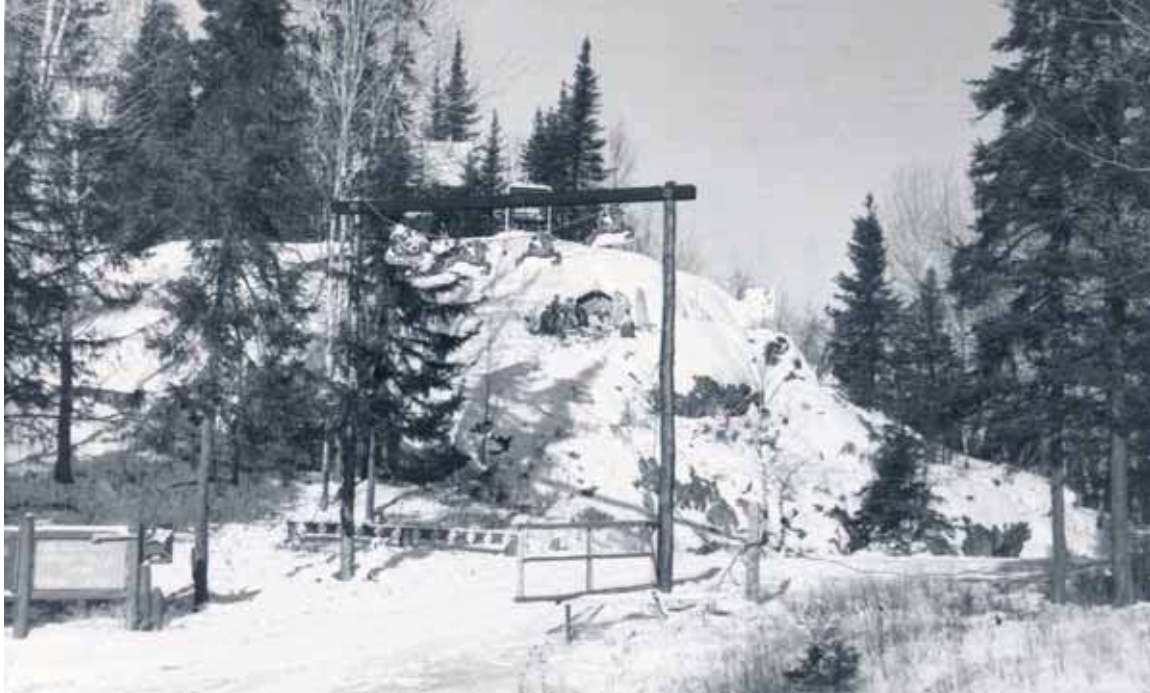
Figure 4- 27: Entrance to Chik-Wauk Resort during Griffis' ownership (source: C-W 228)

The interesting topographic features were utilized when developing the resort. The lodge and American Plan cabins were situated upon rock outcrops that afforded dramatic views of the surrounding landscape. The scenic qualities of the site were the result of the irregular shoreline, combined with diverse topography, dramatic rock outcrops and masses of evergreens and northern hardwoods. These combined provided a high level of visual diversity and interest. One example is at the entrance of the property, where a rock knoll rises above the road and provides a backdrop for the entrance sign (see Figures 4-27 and 4-28). The property retains a high level of integrity associated with topography.

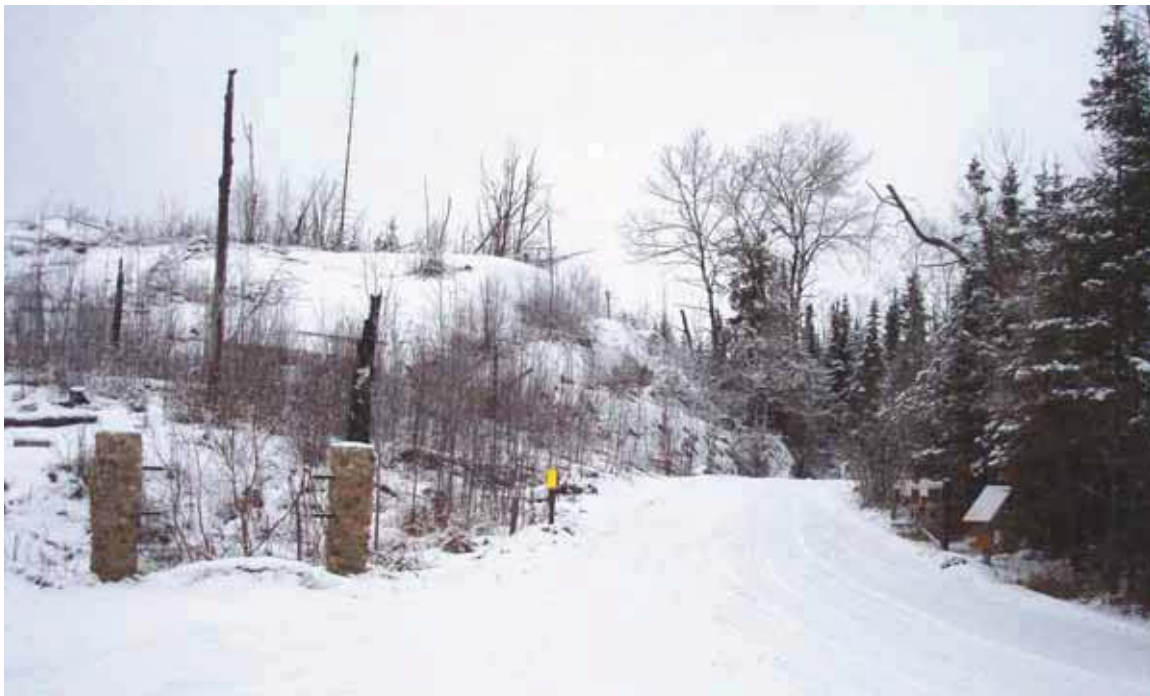
Figure 4- 28: Entrance to Chik-Wauk Museum and Nature Center, December 2012 (source: QEA)

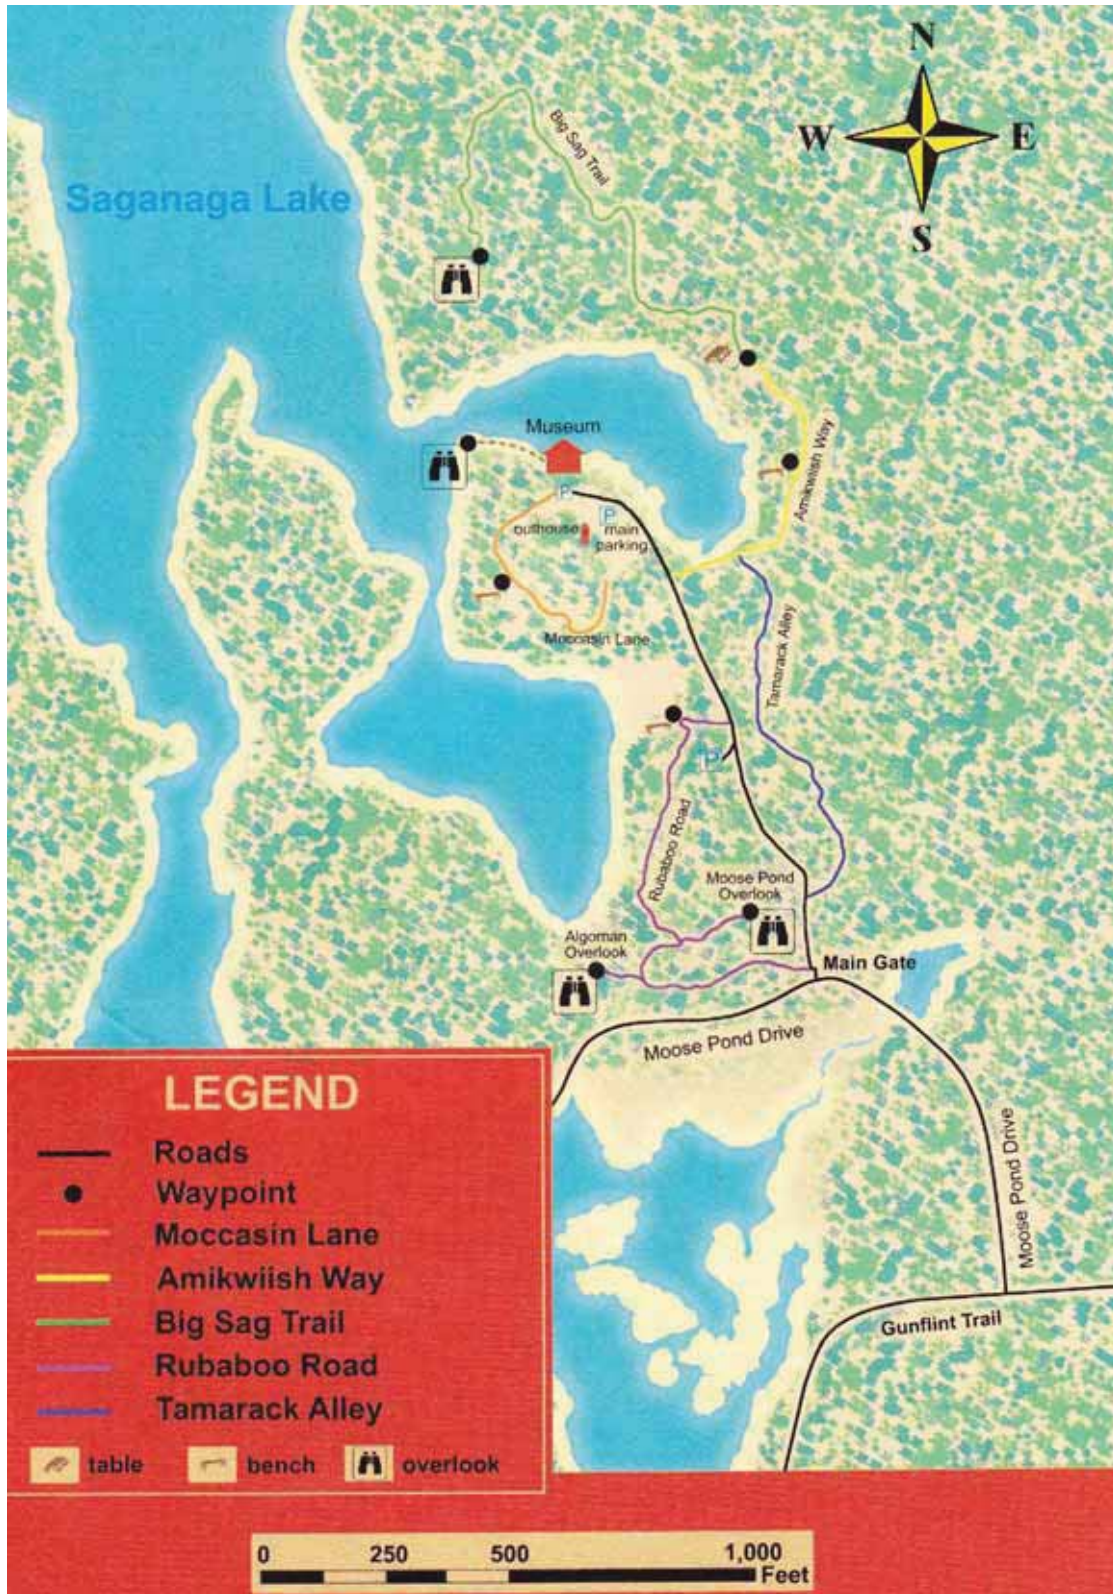
Figure 4- 29: Chik-Wauk Museum and Nature Center Trail Map, 2012 (source: Chik-Wauk Museum and Nature Center)

During the period of resort operation, trails at the resort were limited to those providing access to the buildings, the pedestrian bridge, and a trail that extended to the northeast to a site called "Lookout Point." Current trails on the property that related to those historic routes include Moccasin Lane, Rubaboo Road, and Amikwiish Way.

Patterns of circulation contribute to the significance of the Chick-Wauk landscape. The entrance road, parking area, and three trails (Moccasin Lane, Rubaboo Road, and Amikwiish Way) retain integrity.
